WALKIN THE WATERSHED - STREAM TEAM 2007
Shoreline Survey Findings

Stream Segment: EB-1

Stream: Center Brook

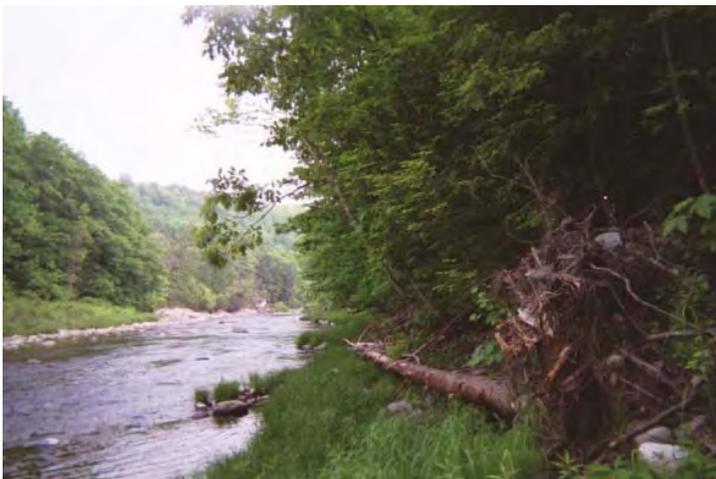
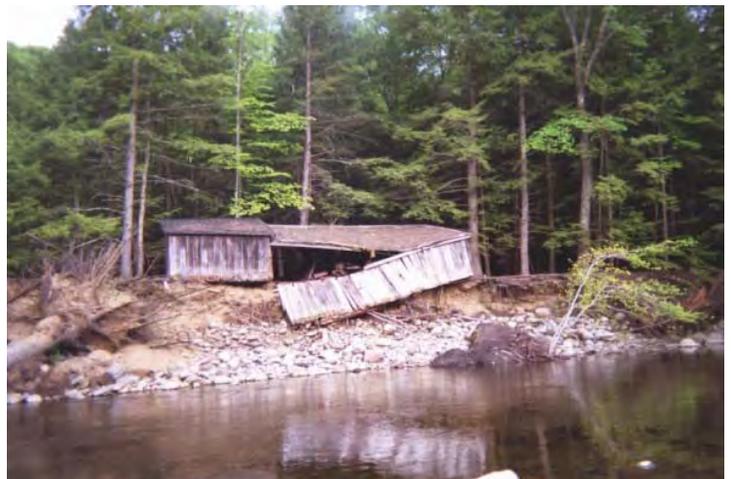
This section of the river is generally buffered from development - falling in building one exception - and is very rocky with frequent steep banks and ledge and outcroppings. The water was clear everywhere with just a few very small spots alongside with oil sheen. Water seemed very warm for the beginning of June. The knotweed and possible hogweeds are taking over in a few areas.

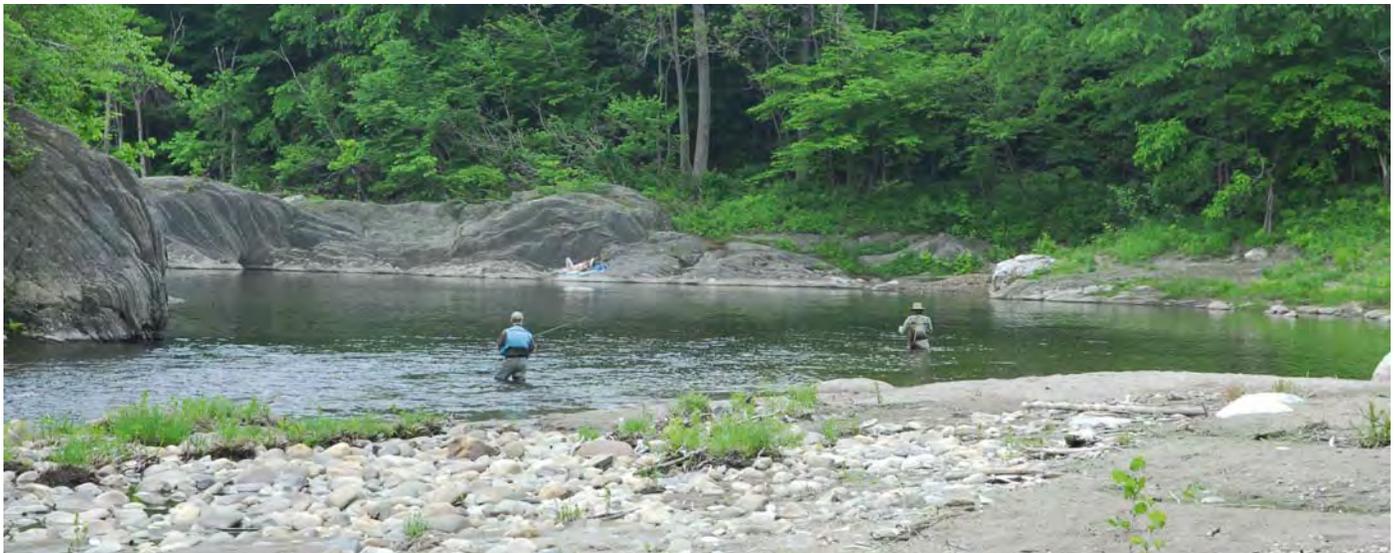
PROBLEMS:	ASSETS:	PROIRITIES FOR ACTION:
1) Glossy buckthorn as noted; 2) Westerly bridge abuttment is in some danger of damage due to tree roots	1) Attractive for fishing when water depth is sufficient; 2) The old bridge abuttements	1) About 2-4 hours of chainsaw work would lengthen life of the westerly bridge abuttment
