**WESTFIELD RIVER WATER QUALITY  
MONITORING PROJECT**

**FINAL REPORT  
2008-04/604b**

**Prepared By  
Pioneer Valley Planning Commission**

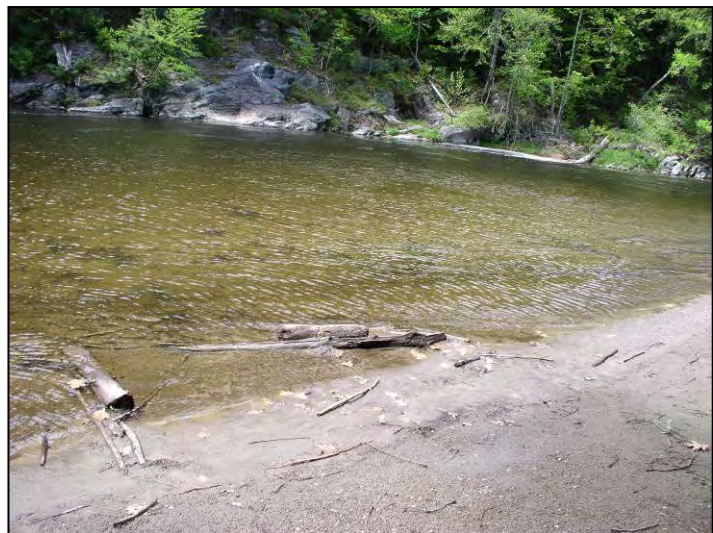
**Figure 1 East Branch Gardner State Park Beach**

Gardner State Park beach had high E. coli levels on 5/18/09 and 10/25/09.

MA DCR suspects an upstream septic system at a local restaurant to be the source of the problem.

On the East Branch at Gardner State Park, water quality continues to be poor. Results for Gardner State Park beach had high *E. coli* wet weather levels on May 18, 2009 (461.1 MPN/100 mls) and October 25, 2009 (866.4 MPN/100 mls). An upstream source has not been identified.

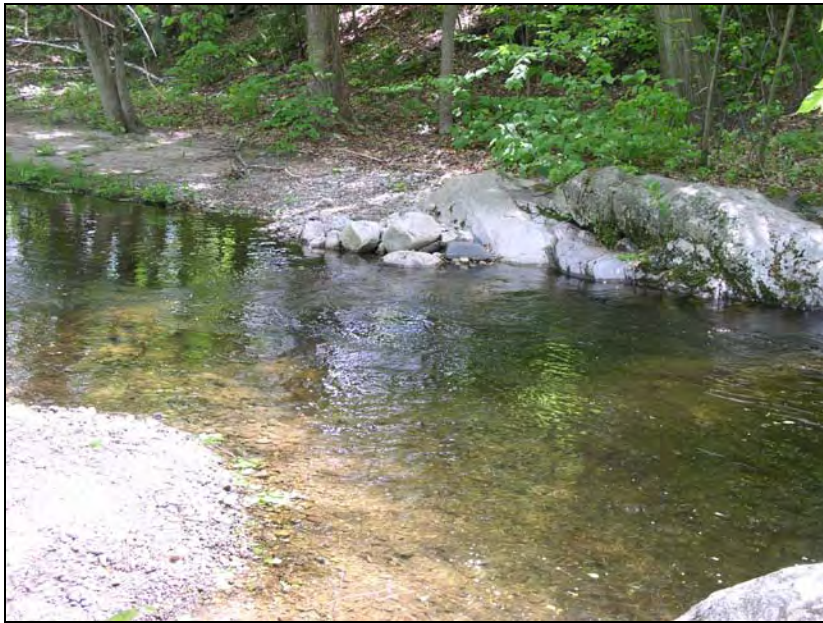
**Figure 2 Bradley Brook**

water from the river per day and return only 100,000 gallons of heated water. Two other sites in Russell, Potash Brook and Bradley Brook, were chosen because they drain water from Blandford where, recently, there have been problems with failing septic systems according to input from the Blandford Board of Health.

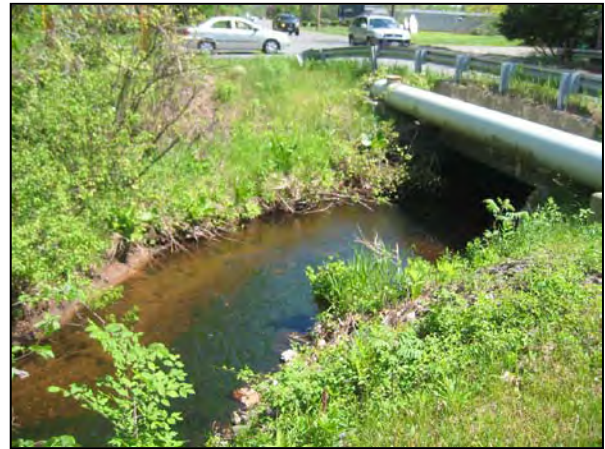
**Figure 6 Pond Brook at Union Street**

Given these results, additional *E. coli* bacteria monitoring is needed at these locations as part of a larger source tracking program. Temperature data collected at the two sites on Pond Brook (PNDB3.3 and PNDB0.01) indicated that the brook may not meet its proposed designation as a Cold Water Fishery. Daily temperature should be collected at these locations to ensure the site is suitable for such a designation.

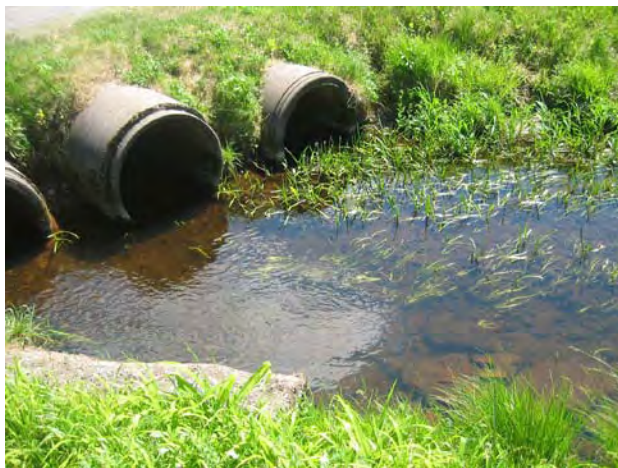
**Figure 7 Pond Brook at East Mountain Country Club**

However, water temperature data for Pond Brook in Westfield (Table 3) suggests further temperature monitoring should be performed to determine if the water meets its proposed Class B Cold Water Fisheries standard. At PNDB3.3 (Pond Brook at East Mountain Country Club), temperature exceeded 20° C in June, July, and August on the single sample dates. At PNDB0.01 (Pond Brook at Union Street) temperature exceeded 20° C in July and August on the single sample dates.

Daily temperature data should be collected at PNDB3.3 and PNDB0.01 on Pond Brook in Westfield to ensure it meets its proposed Class B Cold Water Fisheries designation. Single sample water temperatures above 20°C in June, July and August at PNDB3.3 and July and August at PNDB0.01 were recorded indicating it may not meet standards for Cold Water Fisheries.
