WALKIN THE WATERSHED - STREAM TEAM 2007
Shoreline Survey Findings

Stream Segment: EB-1

Stream: Center Brook

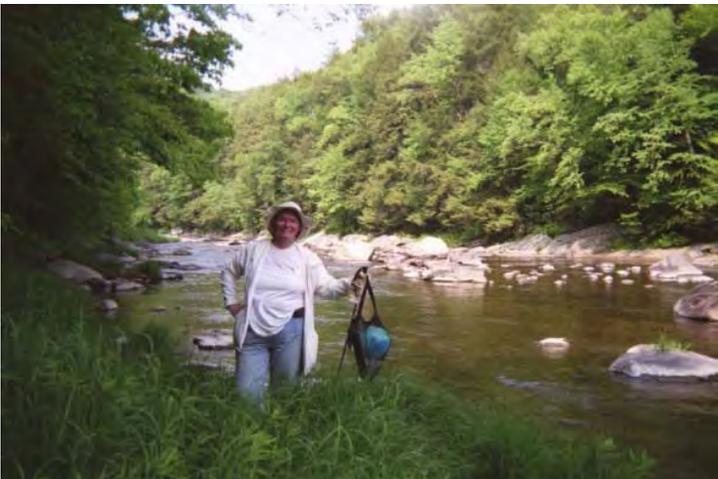
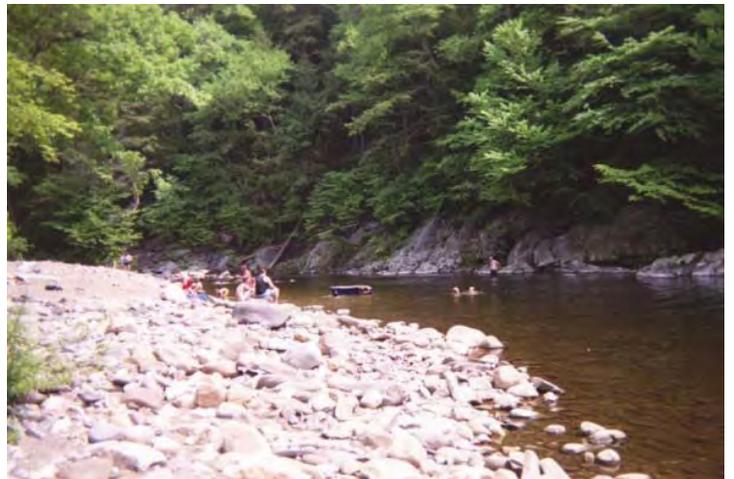
High Bridge: Built by Benjamin Bonney in the 1760's; served as a link along the Boston Albany Post Road. During the Revolutionary War, redcoats marched across the bridge after their defeat in Saratoga, NY. In 1793 a stage coach road was established and a gatehouse was erected on the eastern end to collect tolls; the settlement became known as the Gate. In 1835, floodwaters swept away the bridge along with nearby gristmills and sawmills. All that remains today is the eastern abutment.

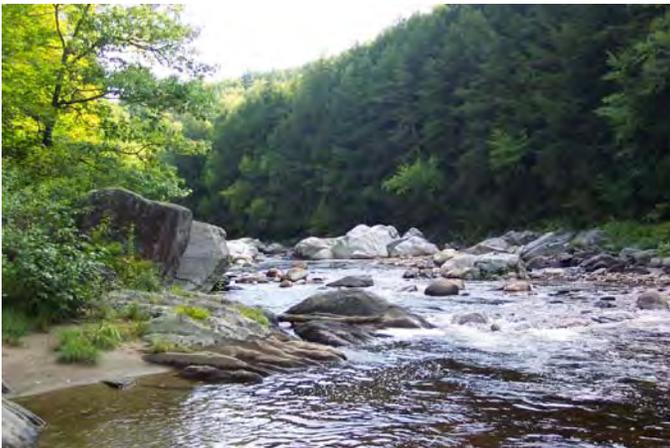
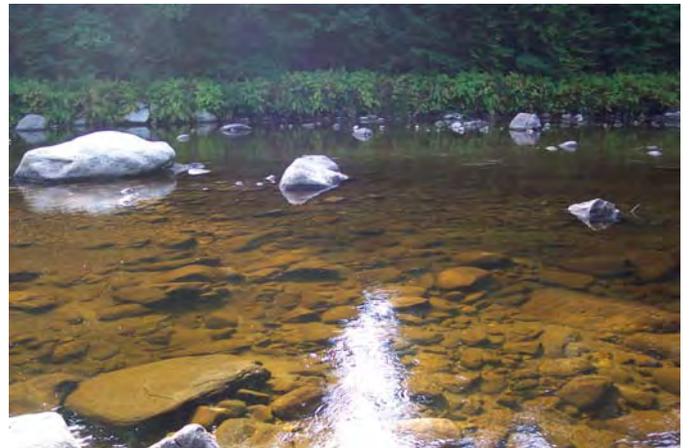
Segment in very good condition, has easy access, protected land use, very good water quality and no obvious pollution issues.

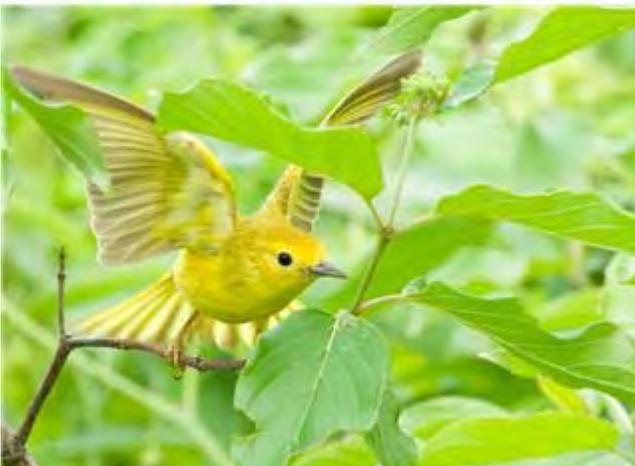
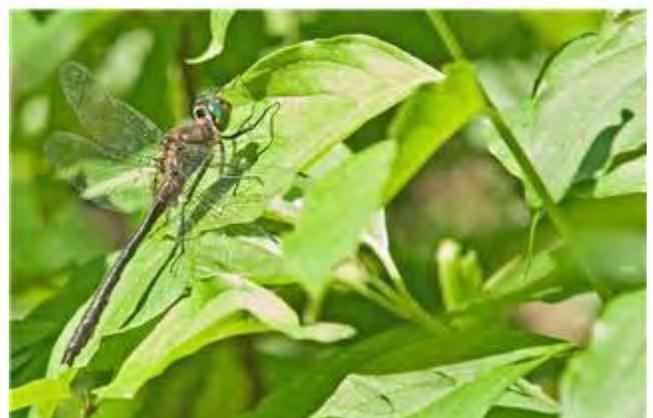
PROBLEMS:	ASSETS:	PROIRITIES FOR ACTION:
1) Glossy buckthorn as noted; 2) Westerly bridge abuttment is in some danger of damage due to tree roots	1) Attractive for fishing when water depth is sufficient; 2) The old bridge abuttements	1) About 2-4 hours of chainsaw work would lengthen life of the westerly bridge abuttment

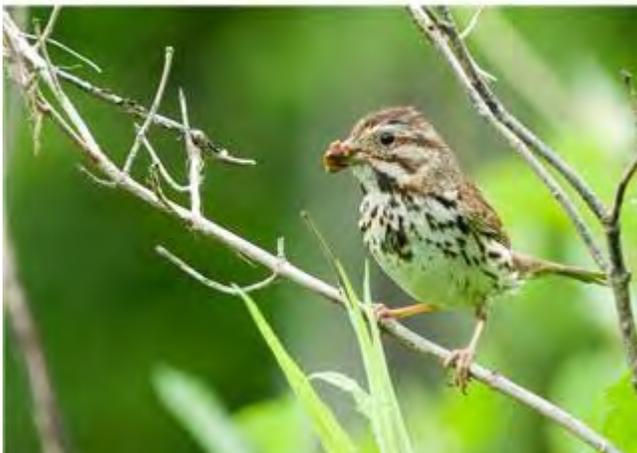
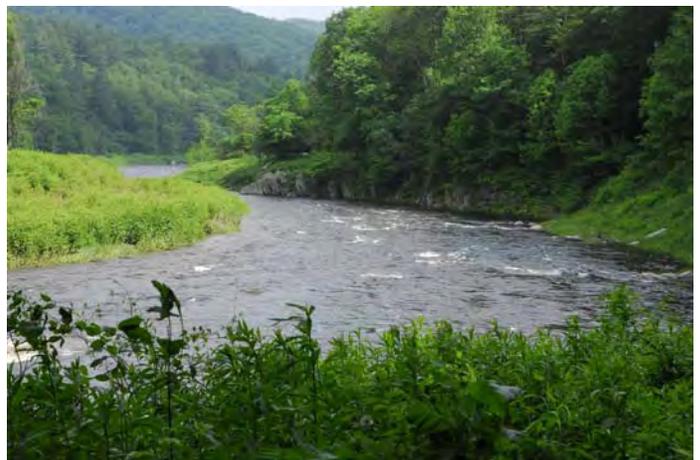
PROBLEMS:	ASSETS:	PROIRITIES FOR ACTION:
<p>1) No particular water problems were noted except it is speculated last summer (low volume) water conditions may result in excessive water temperature rises. The river is broad, shallow and fairly slow here. It is likely fish requiring colder water head upstream in July-August;</p> <p>2) Invasive Knotweed</p>	<p>1) Nearly perfect wildlife habitat for this lat/long;</p> <p>2) River is clean and subject to very little abuse</p>	<p>1) Current use of snowmobiles & ATVs, while prohibited, does not appear to be creating serious problems. Usage and impacts should be monitored for any large change in use level. Snowmobiles and ATVs have been staying on specific trails with very rare travel over river ice in recent winters. Of course, stream crossings and river ice riding have the potetnlial for accidental pollution.</p>

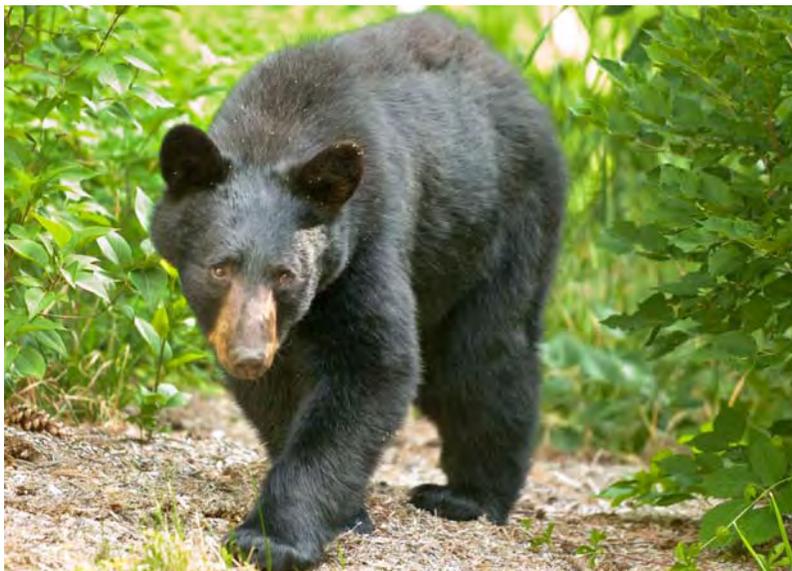
PROBLEMS:	ASSETS:	PROIRITIES FOR ACTION:
<p>1) No top level problems requiring immediate attention;</p> <p>2) There are about a half dozen auto tires that could be removed from the river and river banks during low flow periods in early spring or fall;</p> <p>3) Also this being a downflow section there is a little more trash here but in fact most trash gets all the way to and through the dam itself</p>	<p>1) Between the state and federal agencies these river segments are managed effectively -- the results of which there is substantial human activity coincident with a high level of conservation;</p> <p>2) Since access to the eastern bank of the river is limited by the river itself - that area remains essentially pristine</p>	<p>1) Except for the probability of a study to see if flooding could reduce or limit knotweed distribution there are not other immediate priorities</p>

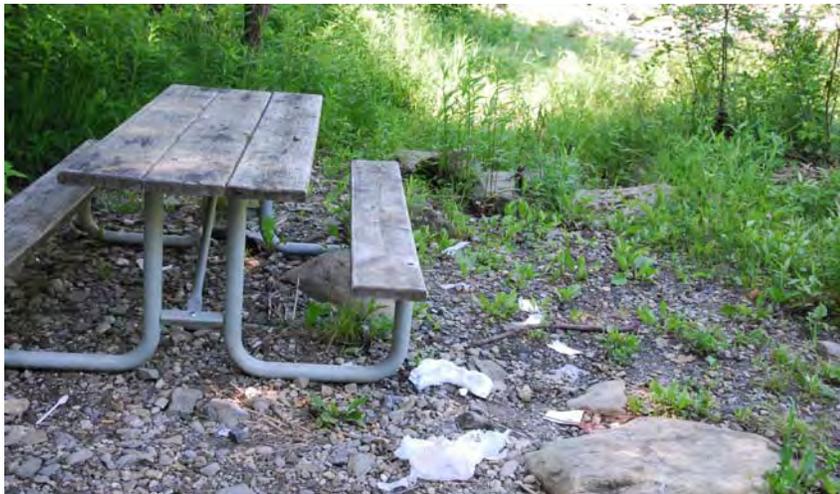
PROBLEMS:	ASSETS:	PROIRITIES FOR ACTION:
<ol style="list-style-type: none">1) Lack of shade throughout segment;2) Purple loosestrife on either side of ACOE access road	<ol style="list-style-type: none">1) Excellent access for recreation;2) Highly varied plant and bird species;3) A lot of historic structures for the hardy hiker	<ol style="list-style-type: none">1) Tree planting should be discussed for this section;2) It would be of value to re-assess the purple loosestrife for a few years to determine its distribution, i.e. stable or growing?

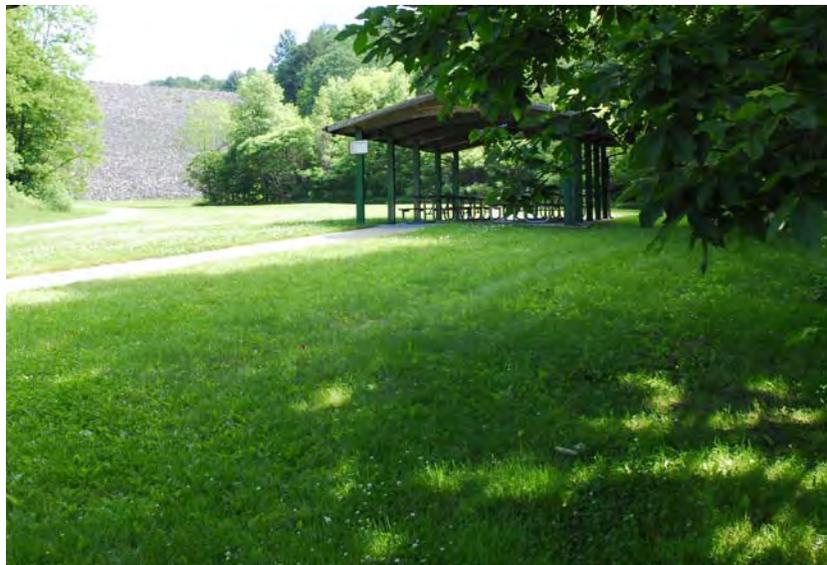
PROBLEMS:	ASSETS:	PROIRITIES FOR ACTION:
1) None specific other than river bottom is much more silted and plankton ricj than all segments surveyed before Knightville Dam	1) Picnic Area; 2) Fishing Opportunities; 3) Flood Control; 4) Water source for boat races; 5) Wildflower Rich	1) Better survey in the fall may be warrented as this one was not thorough

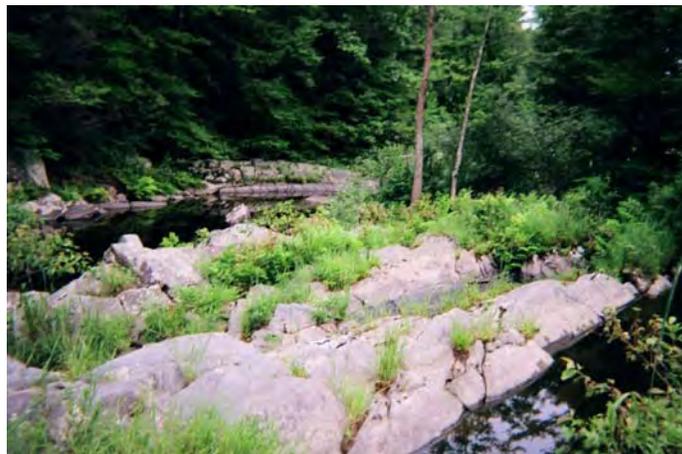
PROBLEMS:	ASSETS:	PROIRITIES FOR ACTION:
1) Invasive species: bittersweet, honeysuckle, phragmites, and Japanese knotweed; 2) Quarry pond and outlet down by river need investigation	1) Local highschool students can use river area for study and conservation projects. Students could be enlisted as volunteer monitors, e.g song birds, invasive plants, etc.; 2) Very little trash observed	1) Invasive Species; 2) Quarry Pond and Outlet need investigation
